83012-1 OR 82597 Replacement Instructions Heat Exchanger Assembly, ASME c/w Burner Door and Flue Box

Applicable Boiler Models

- Ti100-150(C) (ASME Models)
- Ti200
- Lx150(ASME Models)
- Matrix M100(V) (ASME Models)

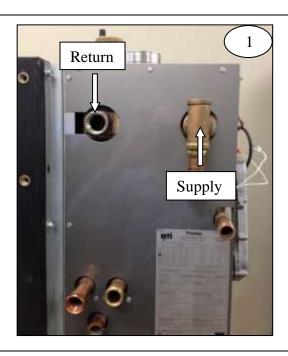
Ti150-200

Disconnect the supply and return piping from the heat exchanger.

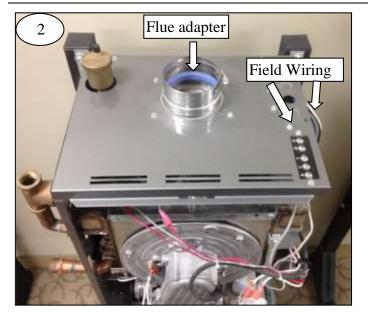
Ti150-200

Remove field wiring.

Remove the jacket top and flue adaptor assembly.

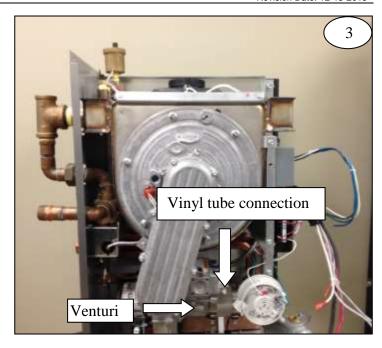
Ti150-200

Disconnect the air inlet from the venturi.

Remove the vinyl tube from the gas valve.

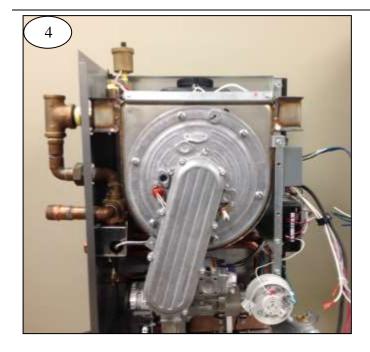
Ti150-200

Remove all the wiring attached to the burner door, blower, gas valve and safety limits.

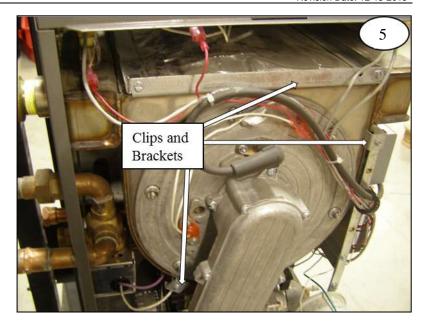
Ti150-200

Remove the hold down clips and brackets.

Loosen the left side of the boiler jacket.

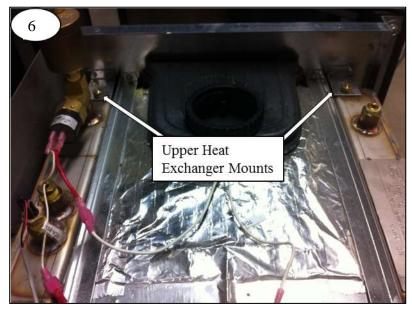
Ti150-200

Remove the upper heat exchanger mounts.

Remove the lower heat exchanger support over the condensate tubing.

Remove condensate tubes from the bottom of the heat exchanger.

Remove the heat exchanger.

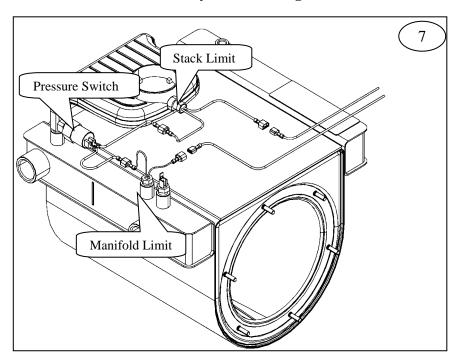
Ti and Matrix Boiler Safety Limit Wiring.

Transfer sensors and safety limits from the old heat exchanger to the new heat exchanger.

Safety limit wiring shown in figure 7.

Refer to Page 5 for safety limit wiring.

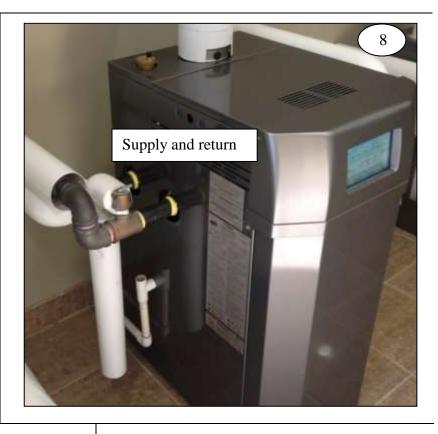
Lx150

Disconnect the supply and return piping from the heat exchanger.

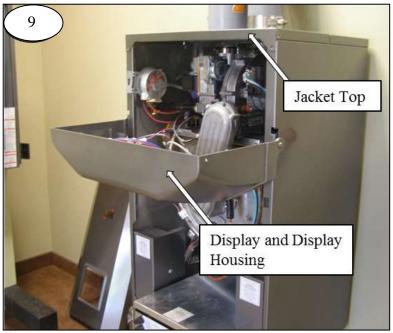
Lx150

Remove display and display housing as an assembly.

Remove front jacket top.

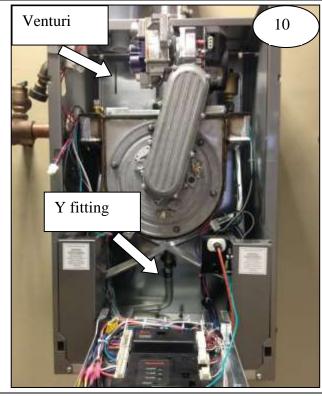
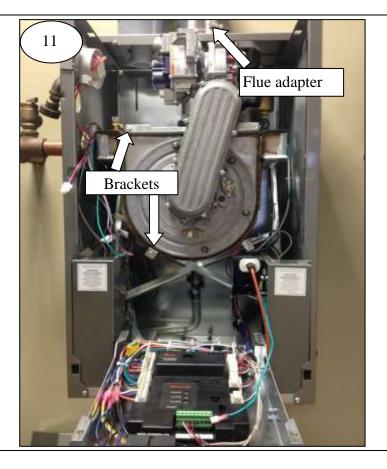
Lx150

Remove wiring attached to the burner door, blower motor, gas valve, and safety limits.

Remove the air inlet from the venturi.

Remove the condensate tubing from the Y fitting.

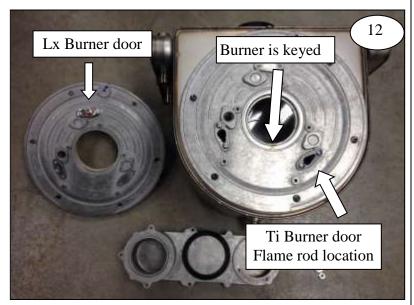
Lx150

Remove the flue adapter from the flue box.

Remove the brackets.

Remove the lower heat exchagner that coveres the condensate tubeing.

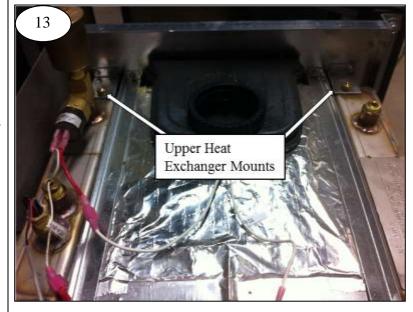
Lx150

Remove the upper heat exchanger mounts.

Remove the heat exchanger.

Transfer the blower motor gas valve, and sensors to the new heat exchanger.

Install the new heat exchanger in the reverse order.

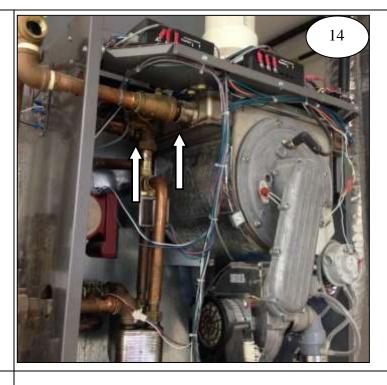
Matrix

Disconnect the supply and return piping from the heat exchanger.

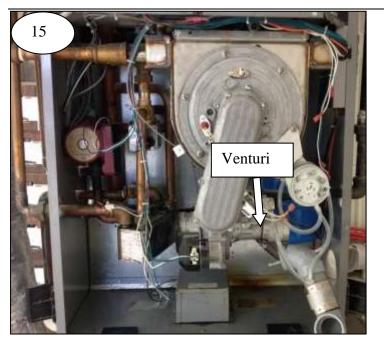
Matrix

Remove wiring attached to the burner door, blower motor, and gas valve.

Remove the air inlet from the venturi.

Remove the wiring attached to the safety limits.

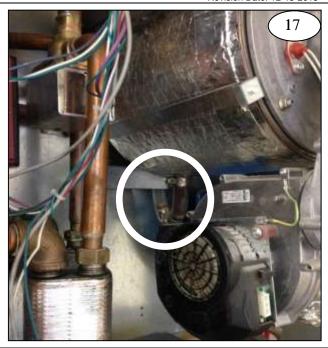
Matrix

Remove the condensate tubing from the Y fitting.

Remove the lower heat exchanger support.

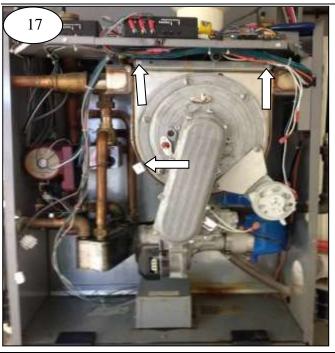
Matrix

Remove the flue adapter from the flue box.

Remove the brackets.

Remove the heat exchagner.

Transfer the blower motor, gas valve, and safety limits to the new heat exchanger.
